SOIL RESOURCE SURVEY

FOR
LAND AT EASTERN AVENUE
PENTWYN
CARDIFF

ON BEHALF OF
CURTIS HALL LTD

CLIENT: CURTIS HALL LTD
JOB NUMBER: CTS/01
PROJECT: LAND AT EASTERN AVENUE, CARDIFF
REPORT TYPE: SOIL RESOURCE SURVEY
REPORT REFERENCE: CTS/01r1a V6

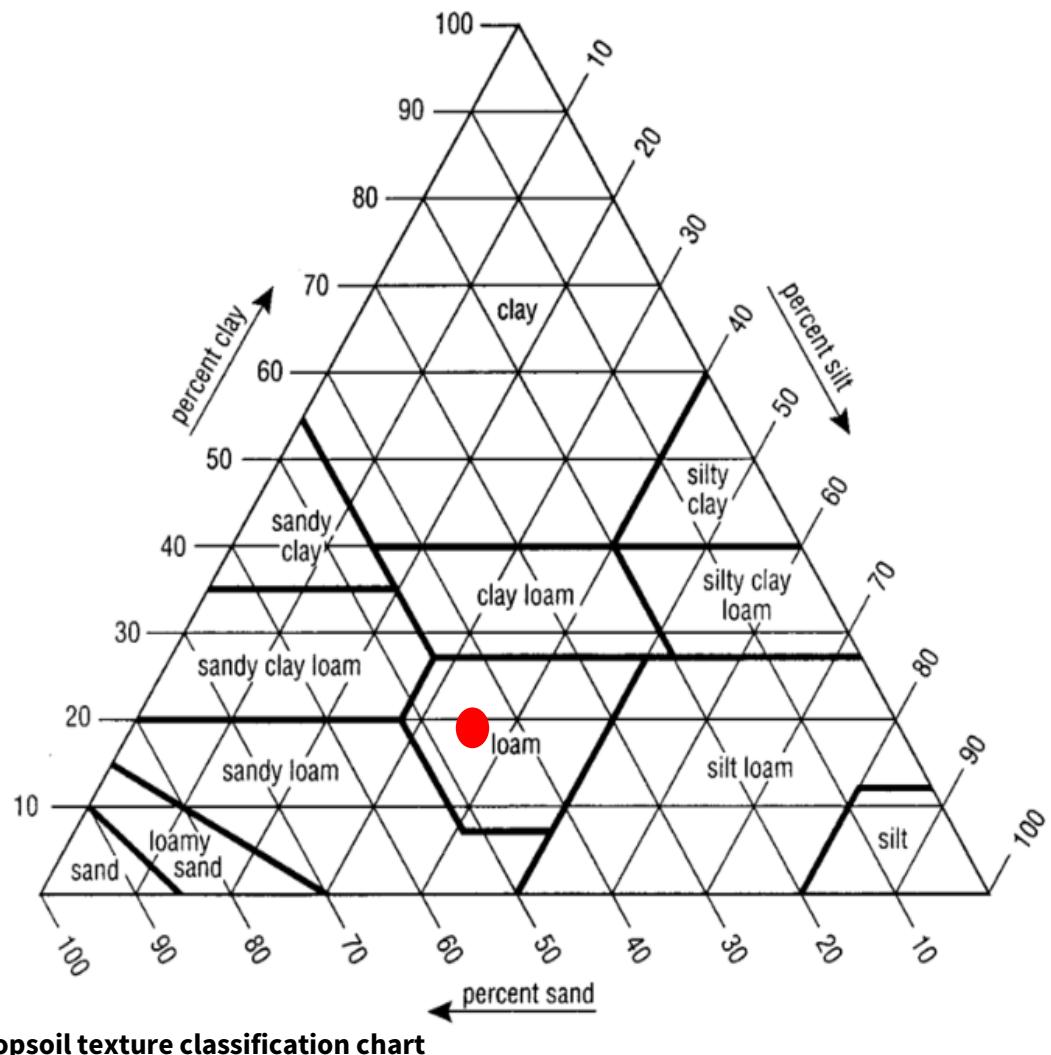
- 3.2.5 The topsoil is plotted on a texture chart below (as a red point). Plot is from a visual inspection and not a PSD assessment. This indicates that the topsoil is loam. It is noted that topsoil texture can vary across a site, particularly when there is a river with varying morphology.

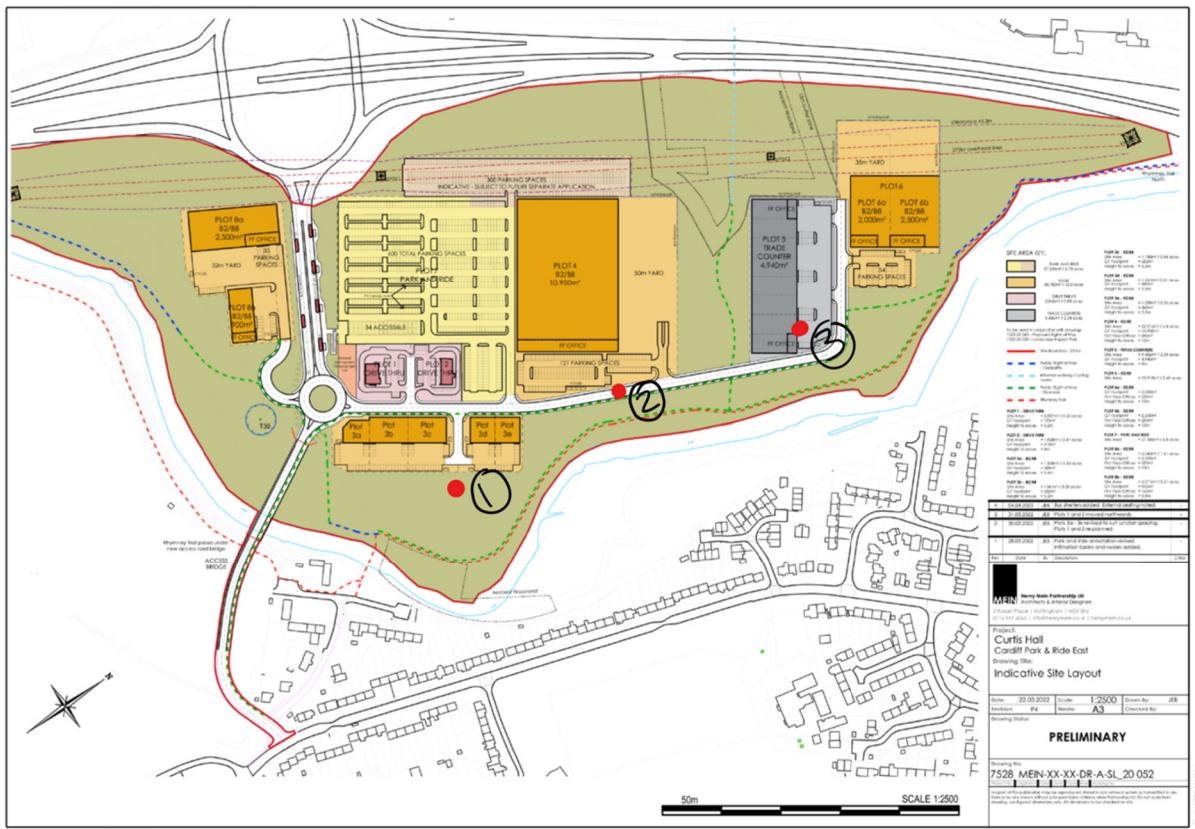
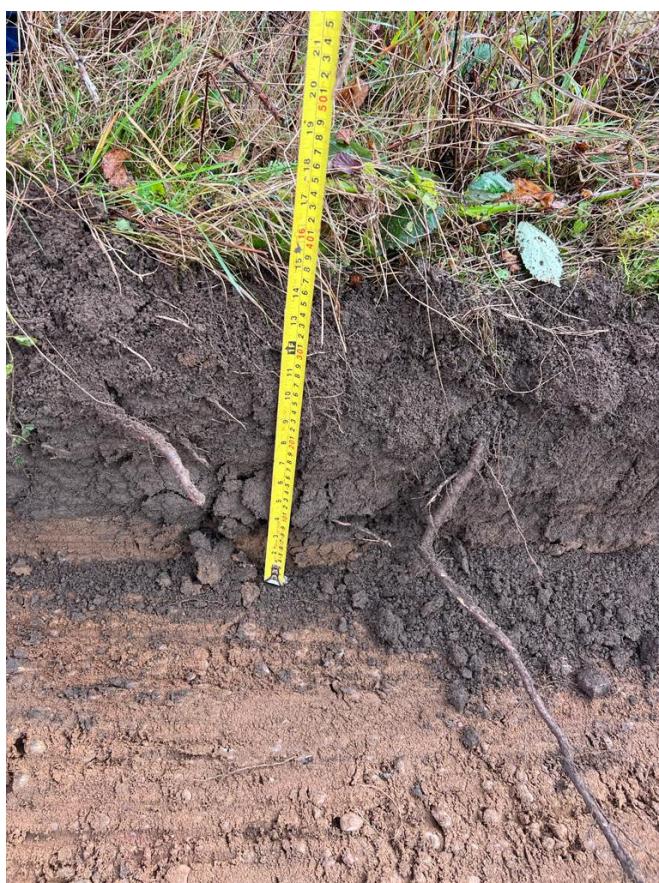
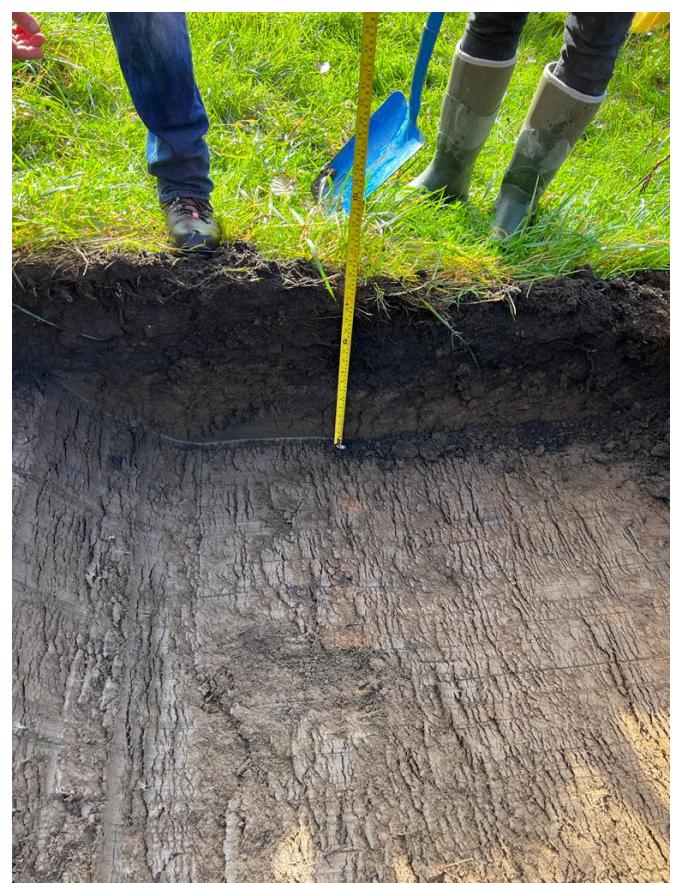
- 3.2.6 Loam soils are considered to be fertile, due to the mix of soil constituents and the presence of humus. This is evident by the variety of vegetation growing in the soil, as shown in the adjacent photos.

Location 1

Location 3
